Airworthiness Directive Amendment 96-12-22

Regulatory Information 96-12-22 CESSNA AIRCRAFT

COMPANY: Amendment 39-9665; Docket No. 93-CE-54-AD.

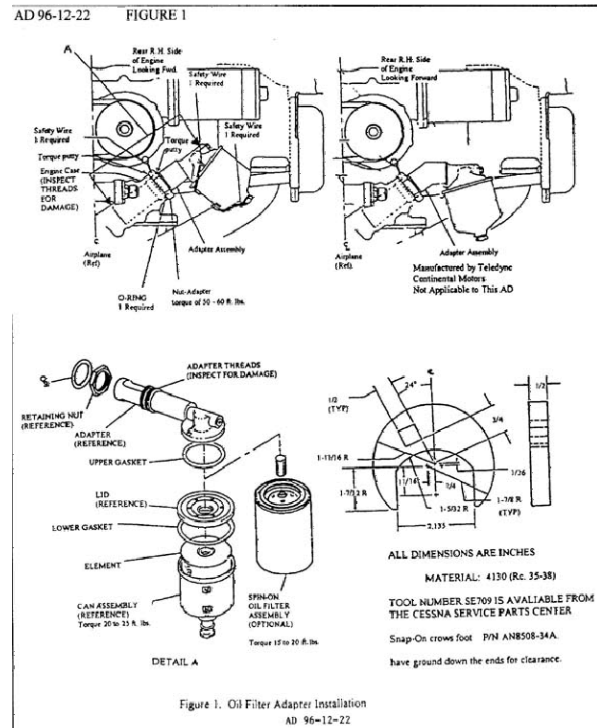
(b) For airplanes with torque putty between the engine filter adapter assembly, nut, and oil pump housing, inspect the torque putty for misalignment, evidence of oil leakage, or cracks.

- (1) If any misalignment, evidence of oil leakage, or torque putty cracks are found, prior to further flight, accomplish the requirements specified in paragraph (a) of this AD, including all subparagraphs.

- (1) Inspect the adapter locking nut installation for evidence of oil leakage.
- (2) Check the torque of the adapter nut installation and ensure that the torque value is within the limits of 50 through 60 foot pounds.
- (3) If evidence of oil leakage is found or the torque is not within the 50 through 60-foot pound limit, prior to further flight, remove the adapter and filter assembly, and:
 - (i) Inspect the threads of the adapter assembly and engine for signs of damaged or cracked threads; and
 - (ii) Replace any adapter assembly and engine oil pump housing (if necessary) that have evidence of thread damage or cracks.
- (4) Apply torque putty between the engine filter adapter assembly, nut, and oil pump housing as specified in Figure 1 of this AD.
